Specialized Inspection
and Diagnostic Services

Your Project

Thermographic Inspection

Apartment / House

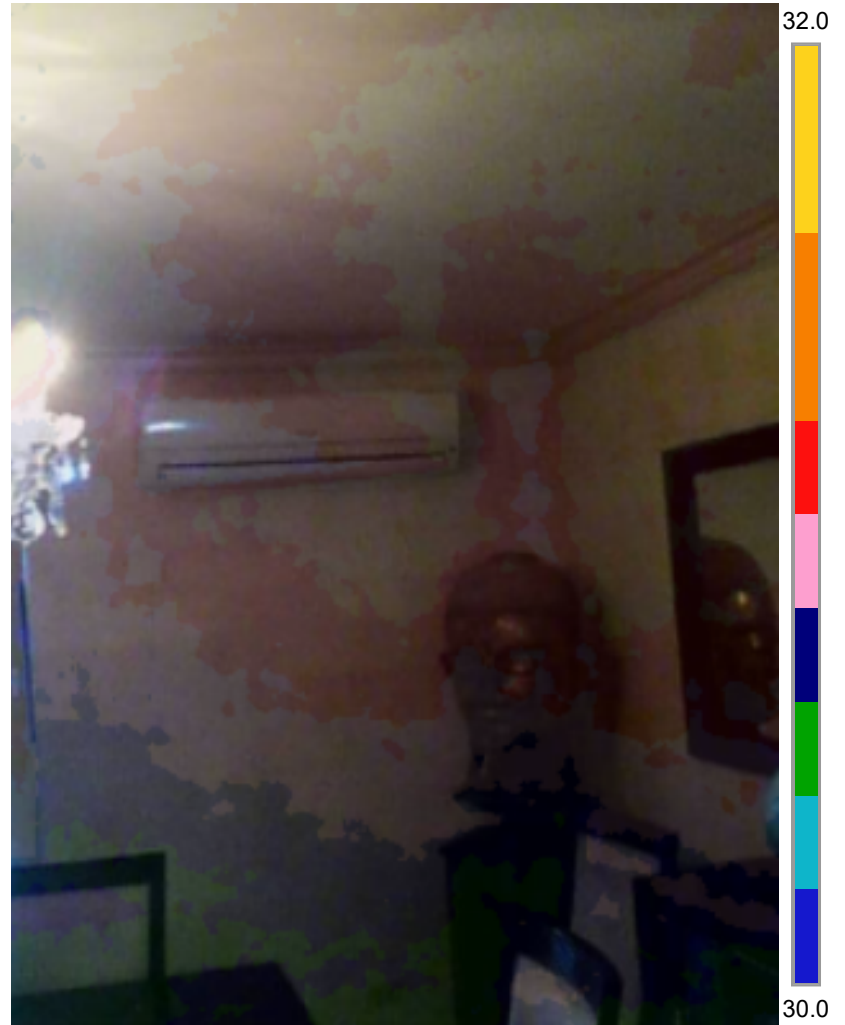
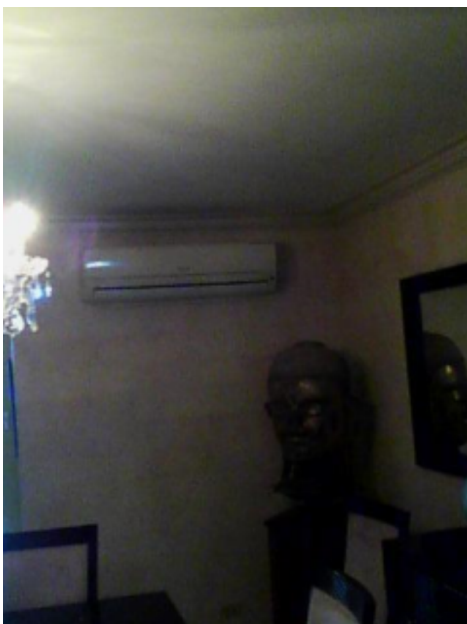
FLIR53653.jpg FLIR E8 Wifi 639033909

Possible Origin of Damage Detected:

Possible damage related to the installation of the air conditioning unit located above this position

We observe a possible damage in the air conditioning unit due to the humidity that moves from the upper floor, this humidity will affect the floor of the area and the areas adjacent to and below this position

The air conditioning unit that we see in the image does not present damage at this time, but it must be checked by a qualified technician due to the exposure of moisture from the ceiling which will accelerate any damage that could occur in the future.

It is important to carry out an inspection on this position to identify the origin of the damage and identify if there are unknown sources that can cause the displacement of humidity that produce the situation that is observed.

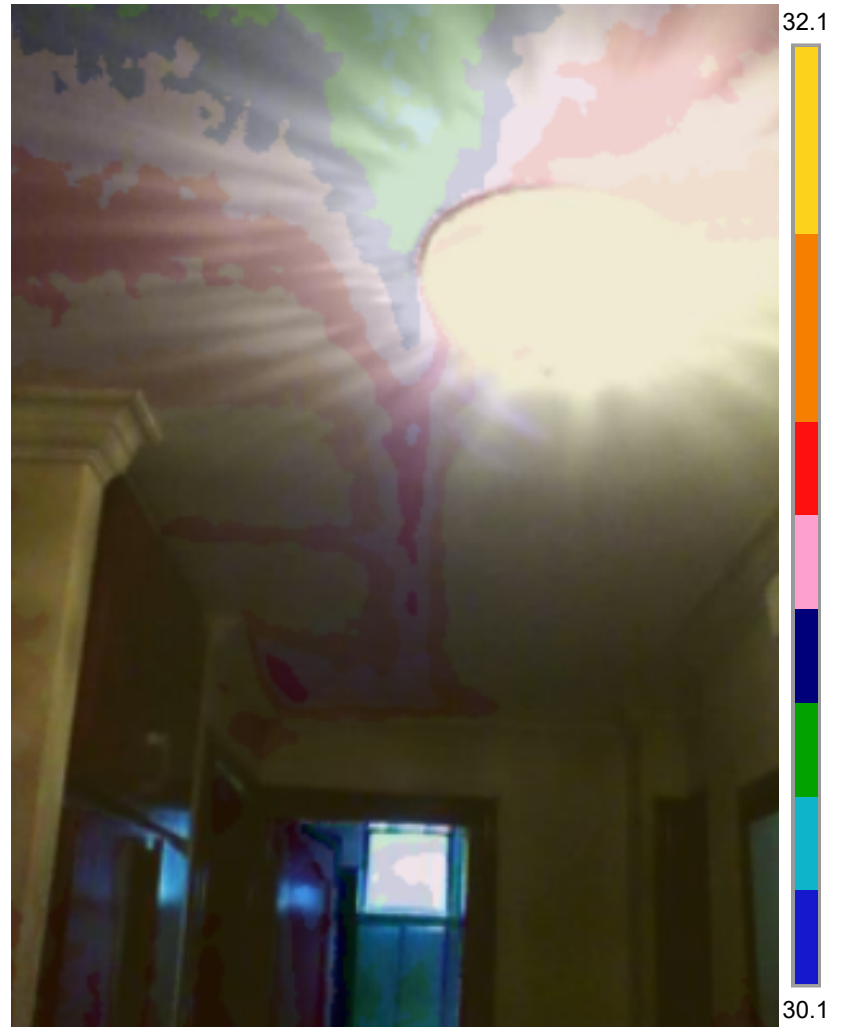
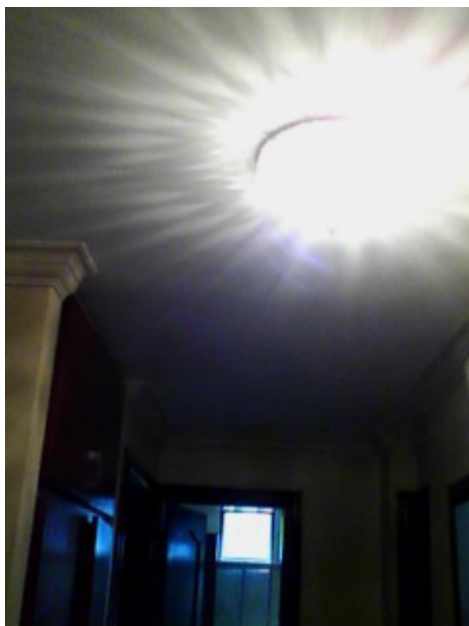
FLIR53655.jpg FLIR E8 Wifi 639033909

Possible Origin of Damage Detected:
 Accumulation of humidity on the ceiling of the apartment with projection towards the side walls to the entrance hall

We observe a problem of humidity that moves from the ceiling affecting the side walls of the corridor and that it would have its origin in the area above this position, if this corridor is adjacent to another apartment We must understand that it will also be affected by humidity identified in the image.

This damage will be reflected in areas below this position as moisture falls by gravity through the structural wall.

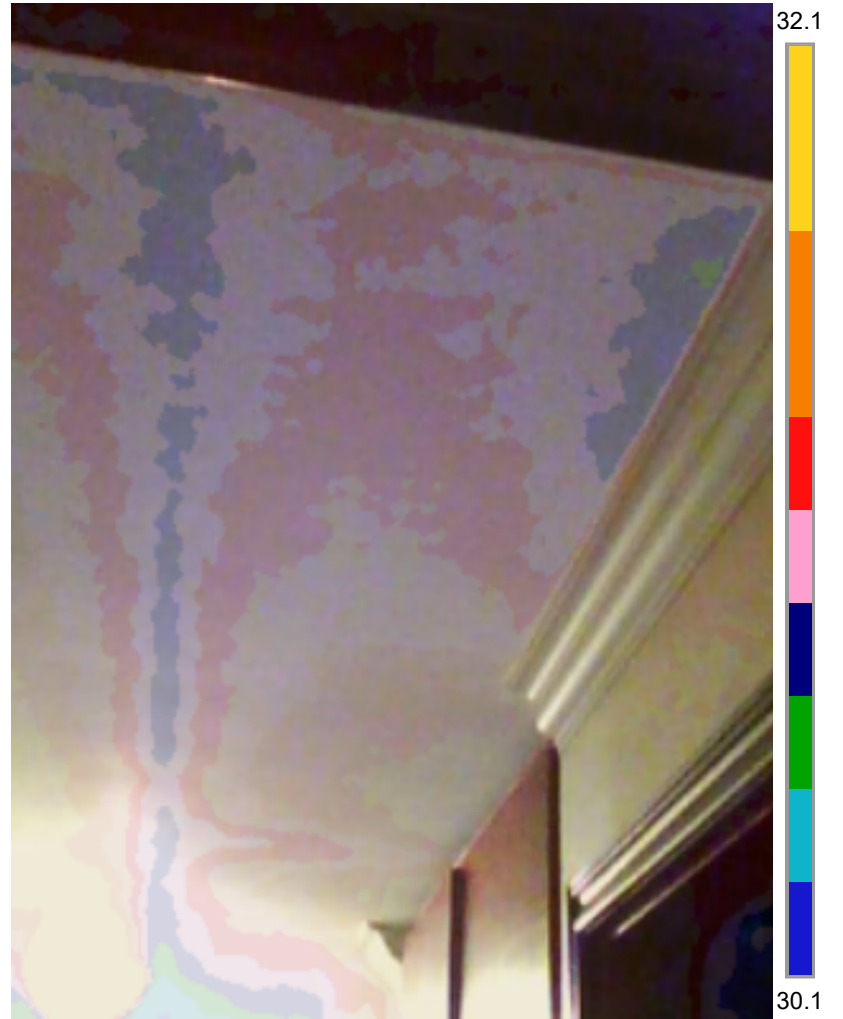
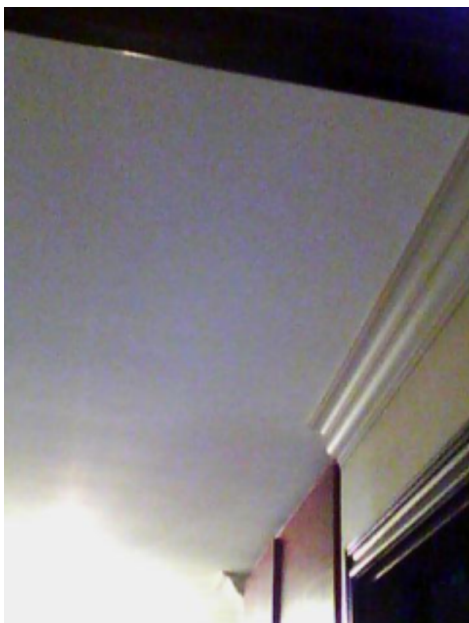
FLIR53656.jpg FLIR E8 Wifi 639033909

Possible Origin of Damage Detected:
 Moisture displacement from the upper area to this position

We observed a moisture problem that moves from the ceiling and falls vertically down the walls. To identify the origin of this moisture, it is necessary to inspect this position and identify equipment and structures that may be causing this situation.

The humidity that we are observing will be reflected in the lower apartments as it moves by gravity vertically through the structural wall.

Possible damage related to a sleeve, this possibility must be evaluated

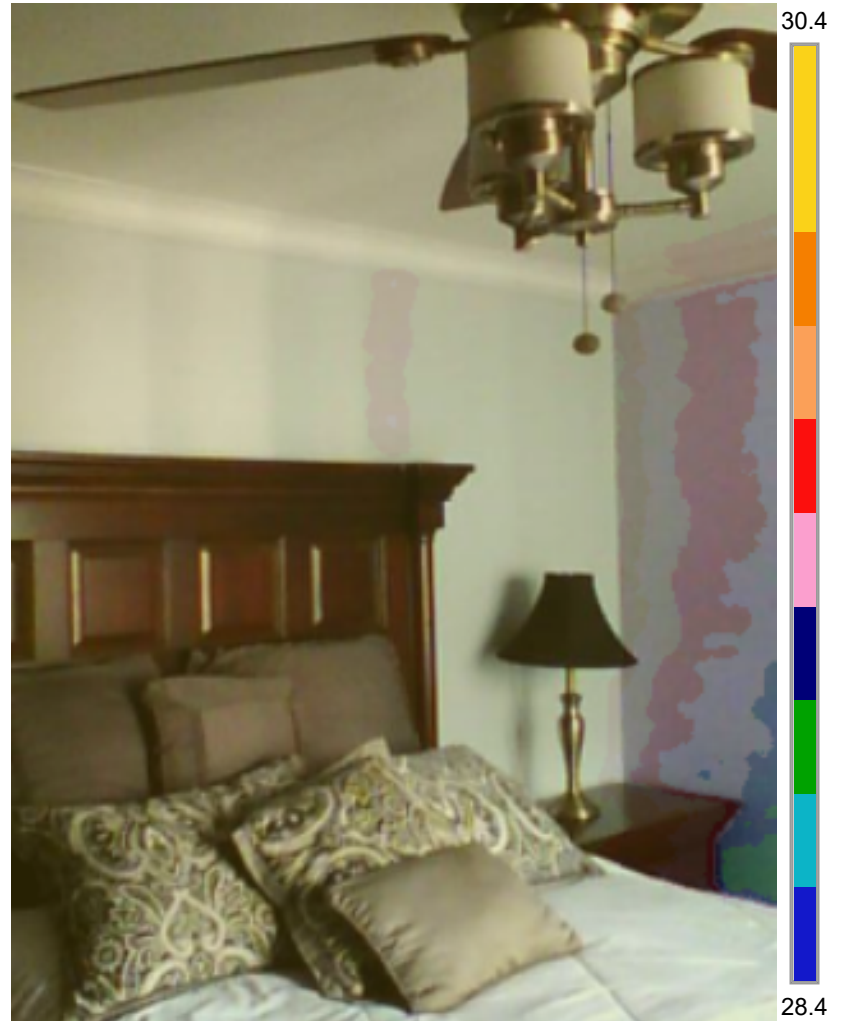
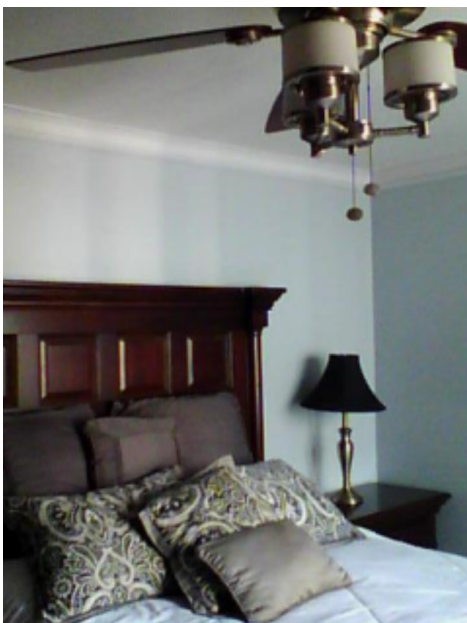
FLIR53657.jpg FLIR E8 Wifi 639033909

Possible Origin of Damage Detected:

Possible damage related to a structural pipe

We see damage moving from the level above to this position and could involve structural piping, the linear pattern we see in the image generally indicates this possibility, however we do not rule out damage moving from the apartment or area above.

This damage will be reflected in the lower area below this position.

If the observed wall is a façade on its back, the possibility of damage related to it or the possibility of damage related to a platform or decorative detail should be considered. If there is a room or an internal area behind this position, said wall should be reviewed. area to detect possible sources of damage

Damage reflected in the internal wall of the apartment due to waterproofing problems on the facades

The humidity that we observe and that appears in the middle part of the wall, and which does not move from the ceiling, indicates the existence of a waterproofing problem in its external part, this humidity will affect the electronic equipment, attached accessories to the wall

It is common to see this damage move several levels so we might see repeating patterns at lower levels if a building is being inspected

To identify the origin of this damage, it is recommended to visit the upper apartment and review the building plans, this will allow us to rule out or confirm an origin of punctual damage.

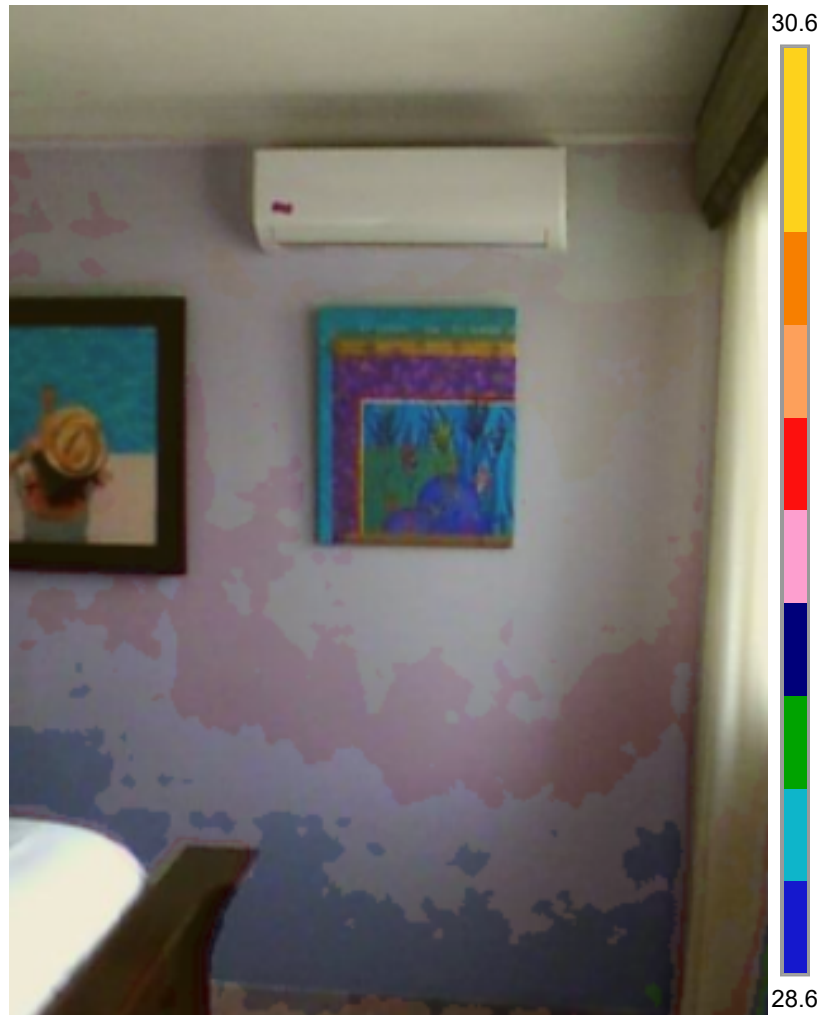
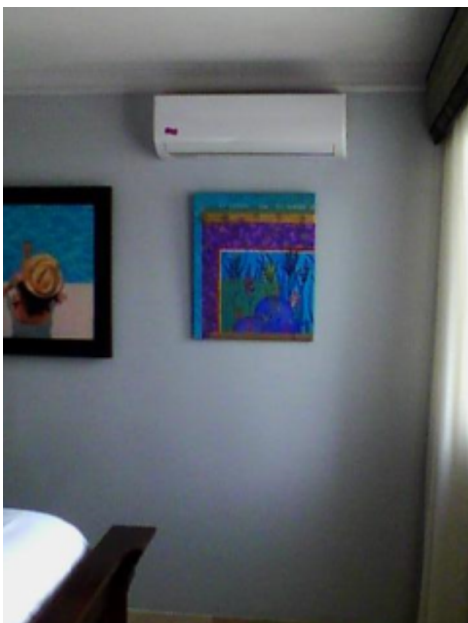
FLIR53658.jpg FLIR E8 Wifi 639033909

Possible Origin of Damage Detected:

Possible damage related to the installation of the air conditioning unit located above this position

We observe a possible damage in the air conditioning unit due to the humidity that moves from the ceiling, this humidity will affect the floor of the area and the areas adjacent to and below this position

The air conditioning unit that we see in the image does not present damage at this time, but it must be checked by a qualified technician due to the exposure of moisture from the ceiling which will accelerate any damage that could occur in the future.

It is important to carry out an inspection on this position to identify the origin of the damage and identify if there are unknown sources that can cause the displacement of humidity that produce the situation that is observed.

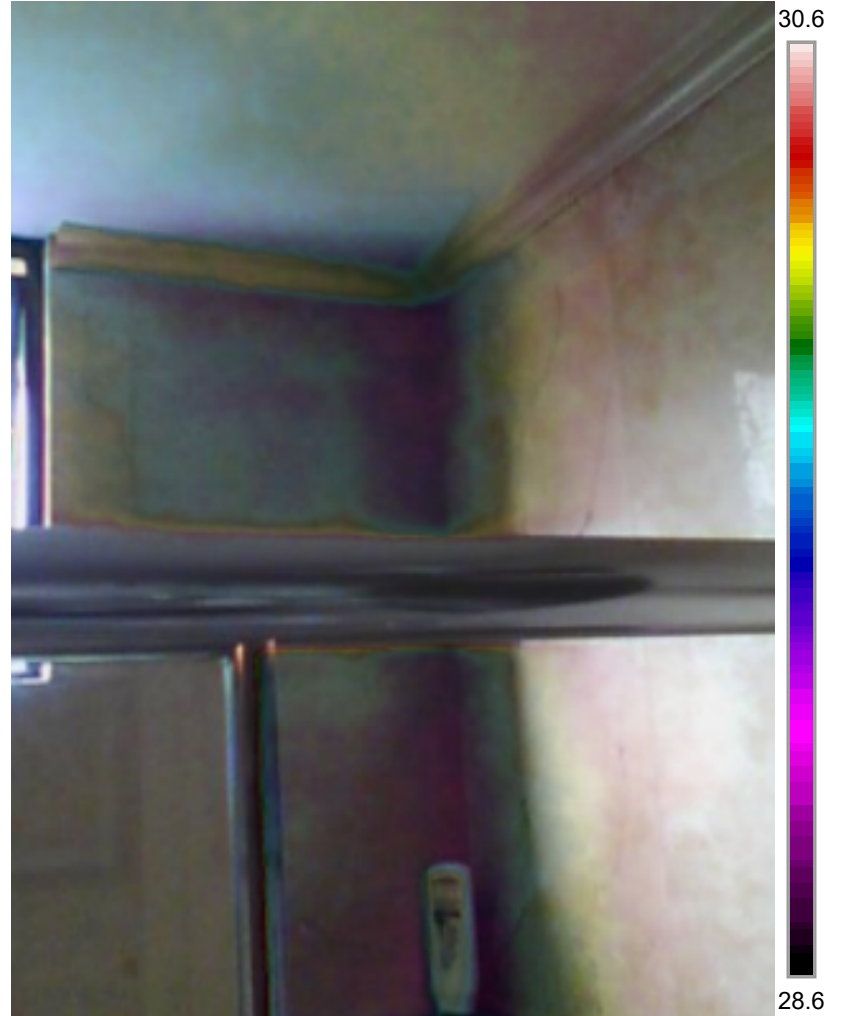
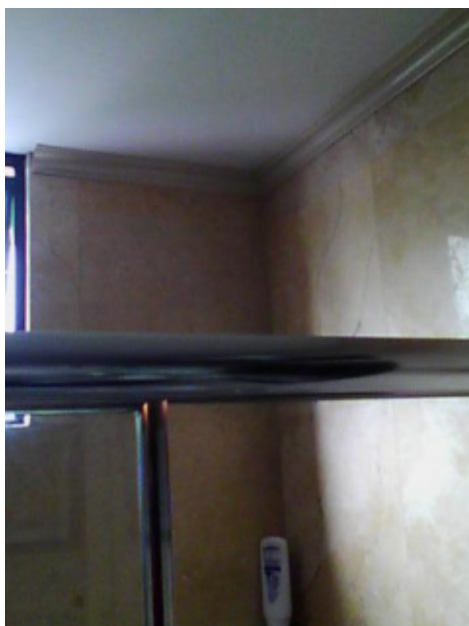
FLIR53661.jpg FLIR E8 Wifi 639033909

Possible Origin of Damage Detected:

Damage to the bathroom ceiling as a consequence of humidity generated by the route of the upper floor air conditioning sleeve

We observed an accumulation of humidity on the ceiling of the bathroom which originates from this position; To identify the origin of the damage, the route of the air conditioning hoses must be reviewed in the plans.

This moisture will affect the reading related to the controls in the inspected bathroom by reflecting in the lower bathroom on its ceiling and walls and in the areas around it.

We do not rule out damage related to waterproofing problems or external platforms if the bathroom wall is oriented towards the façade. If this is the case, we recommend an inspection on the wall / area behind this position.

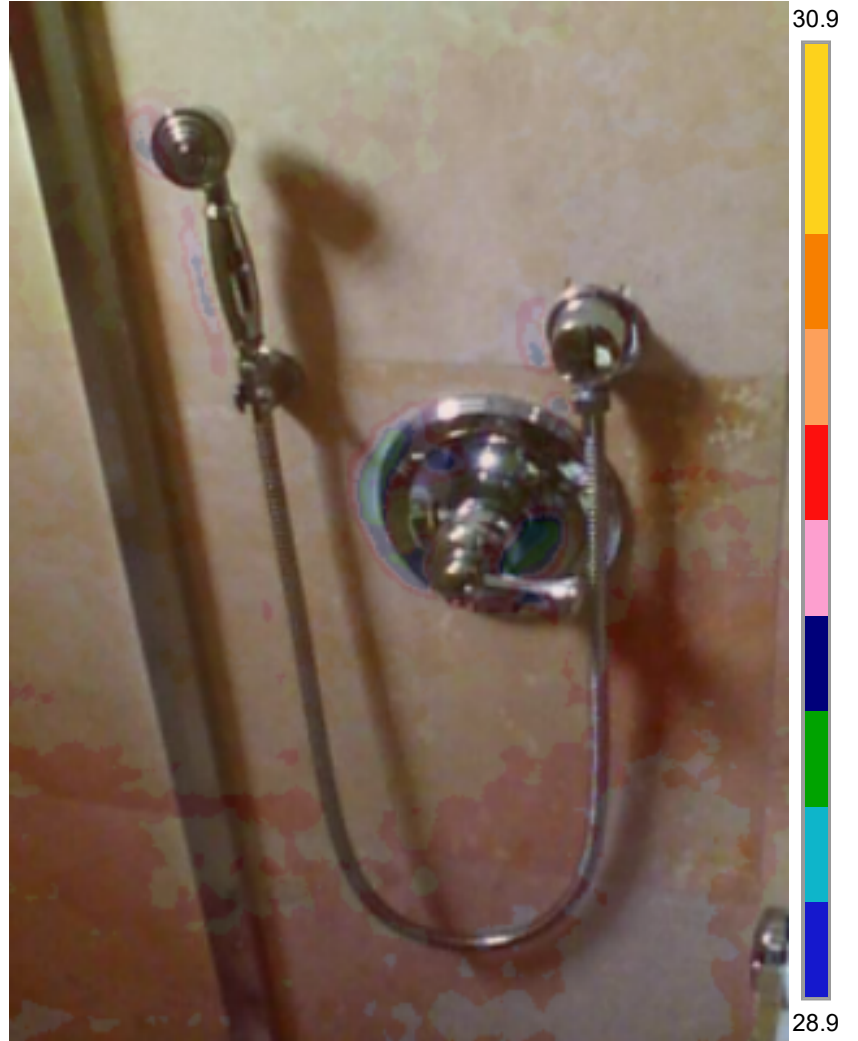
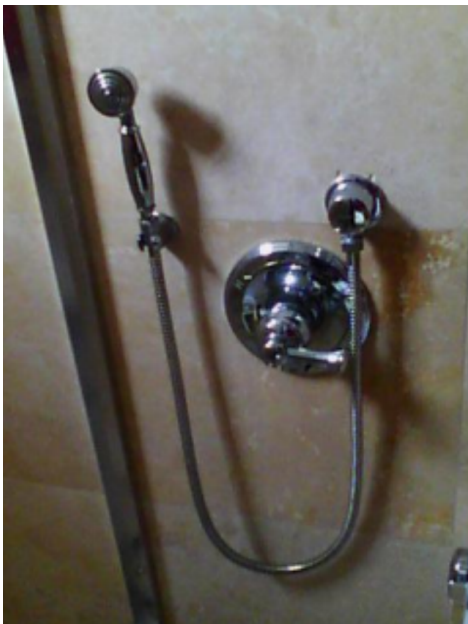
FLIR53662.jpg FLIR E8 Wifi 639033909

Possible Origin of Damage Detected:
 We do not observe damage in this facility

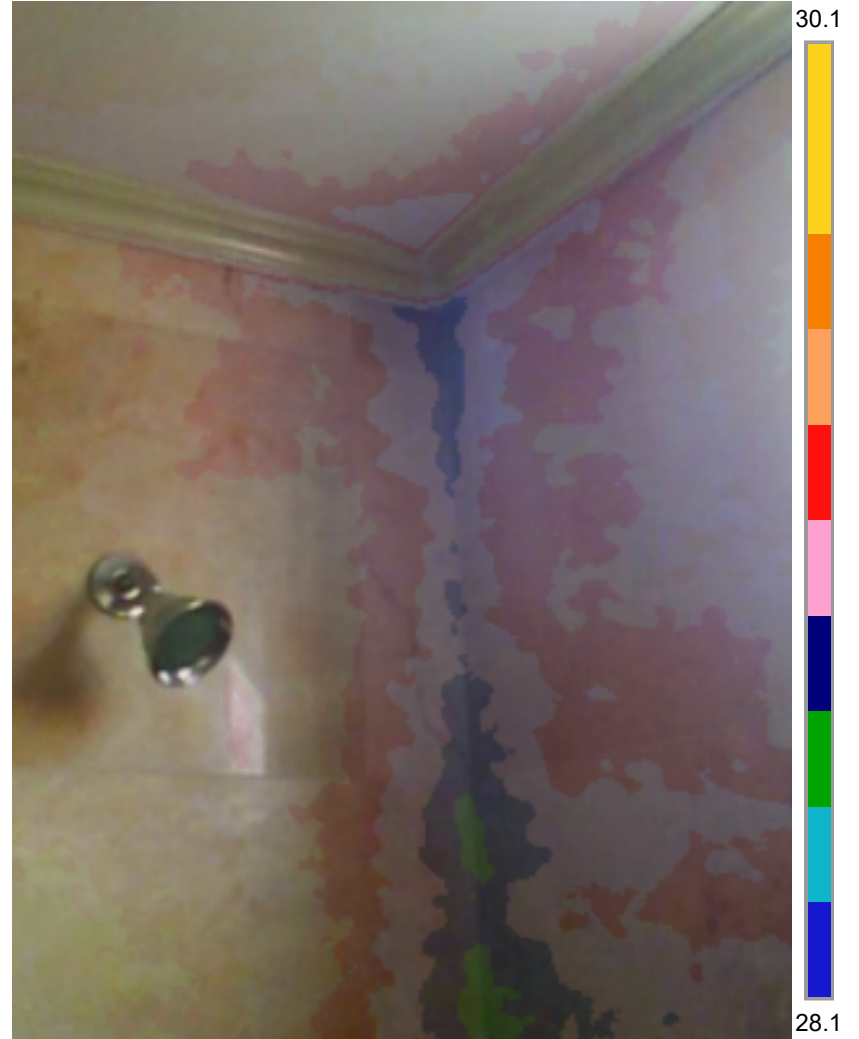
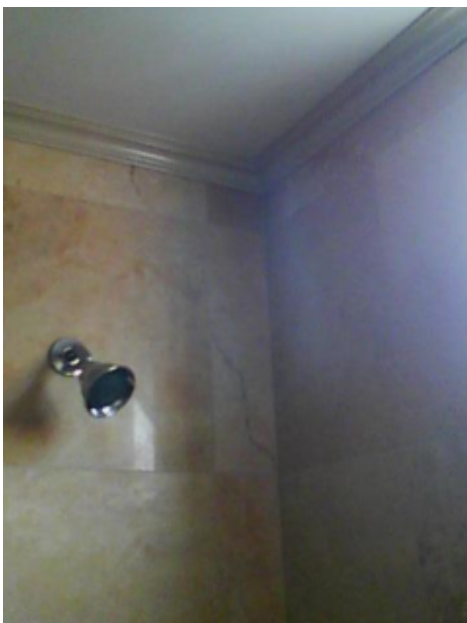
FLIR53663.jpg FLIR E8 Wifi 639033909

Possible Origin of Damage Detected:
 Moisture displacement from the upper area

We observed a moisture displacement issue which could be related to structural piping or moisture buildup on the shower floor located above this position.

To rule out damage related to a structural pipe, we recommend reviewing the building plans to verify if there is such a structure in this position

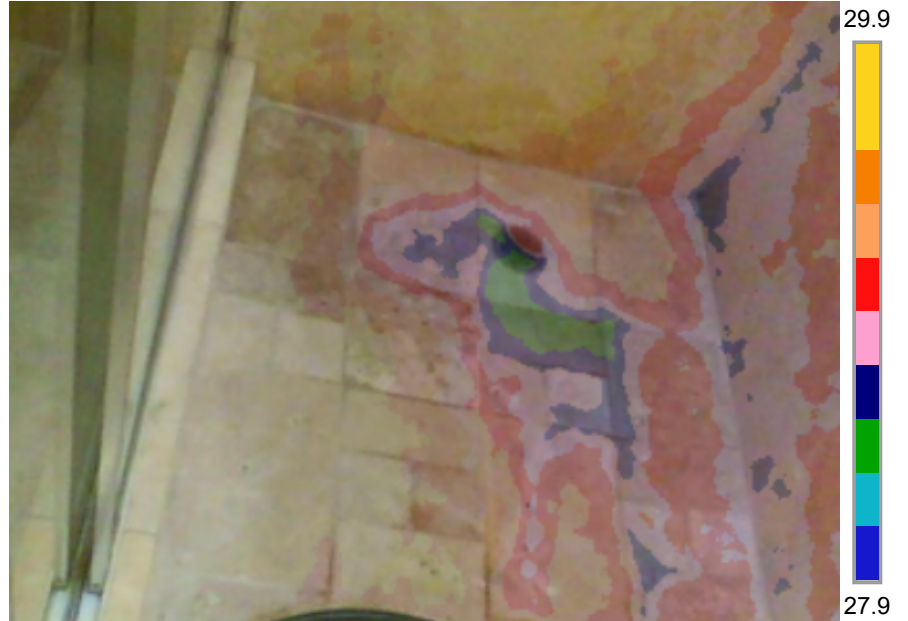
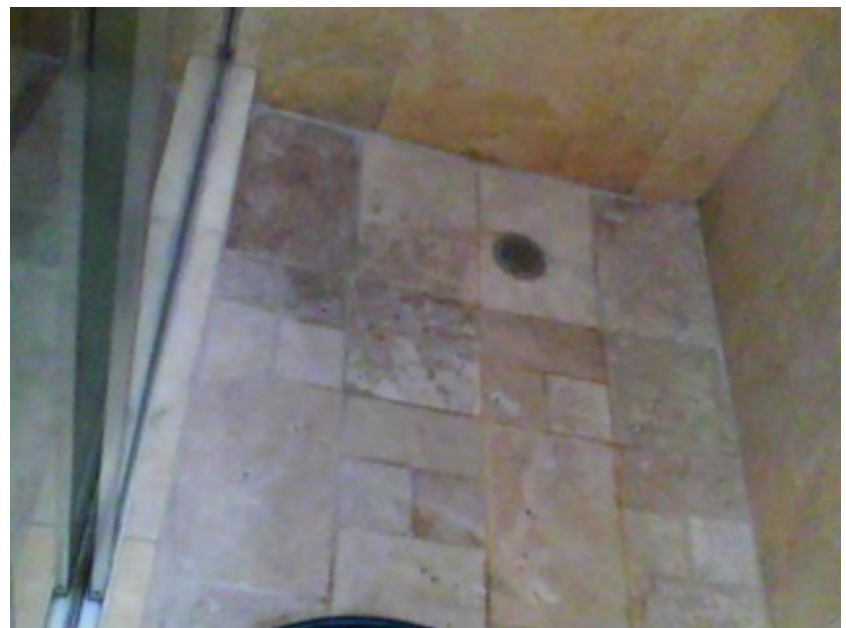
FLIR53667.jpg

Possible Origin of Damage Detected:
 Moisture contained in bathroom floor

The image shows us a damage where the humidity has penetrated the seal of the shower floor which will cause it to reflect on the ceiling under this position, it is also observed a lack of slope and accumulation of water on the shower floor

In order to solve the situation that is observed, we recommend reinforcing the seal of the bathroom floor and the perimeter walls by applying waterproof grout.

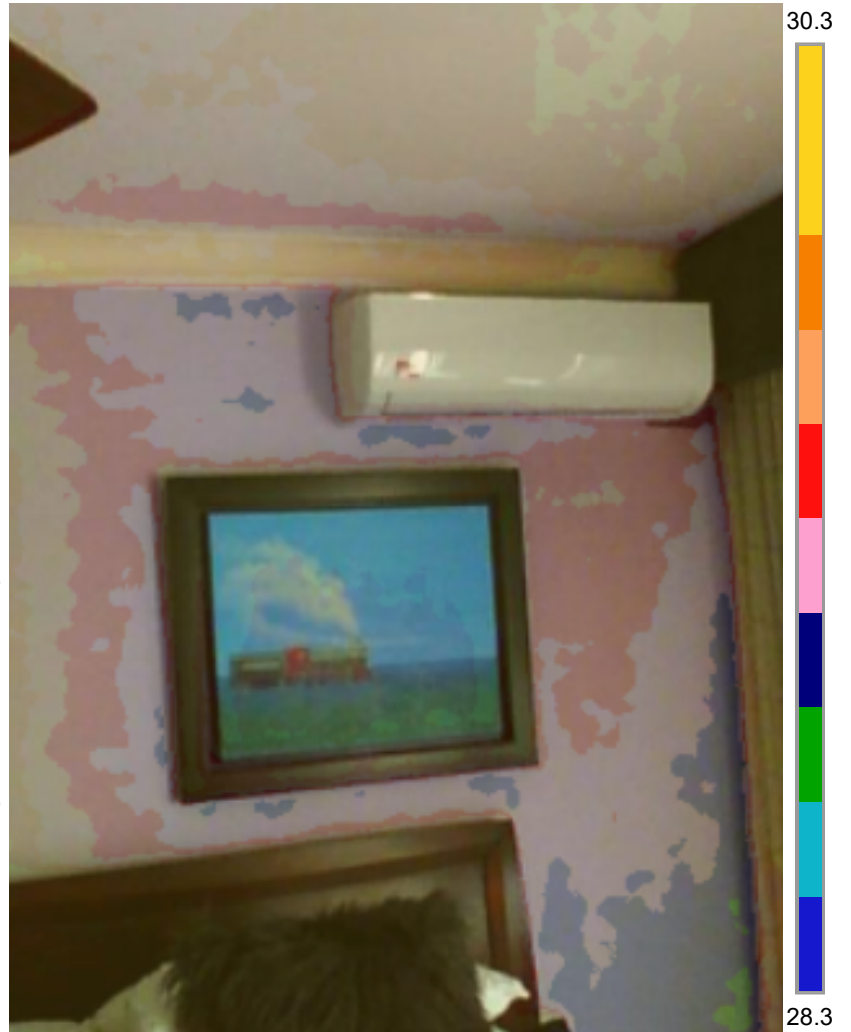
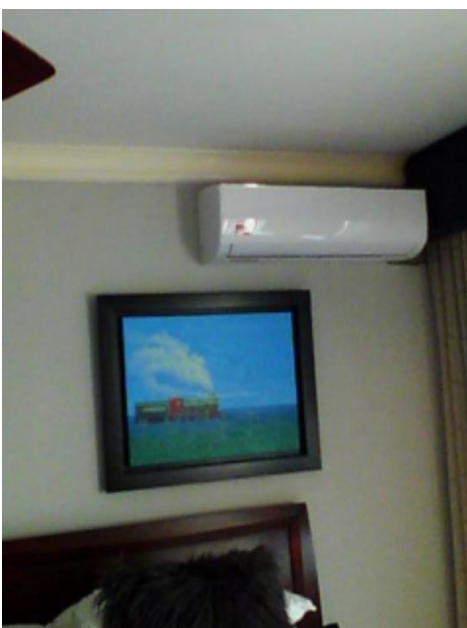
FLIR53670.jpg FLIR E8 Wifi 639033909

Possible Origin of Damage Detected:

Possible damage related to the installation of the air conditioning unit located above this position

We observe a possible damage in the air conditioning unit due to the humidity that moves from the ceiling, this humidity will affect the floor of the area and the areas adjacent to and below this position

The air conditioning unit that we see in the image does not present damage at this time, but it must be checked by a qualified technician due to the exposure of moisture from the ceiling which will accelerate any damage that could occur in the future.

It is important to carry out an inspection on this position to identify the origin of the damage and identify if there are unknown sources that can cause the displacement of humidity that produce the situation that is observed.

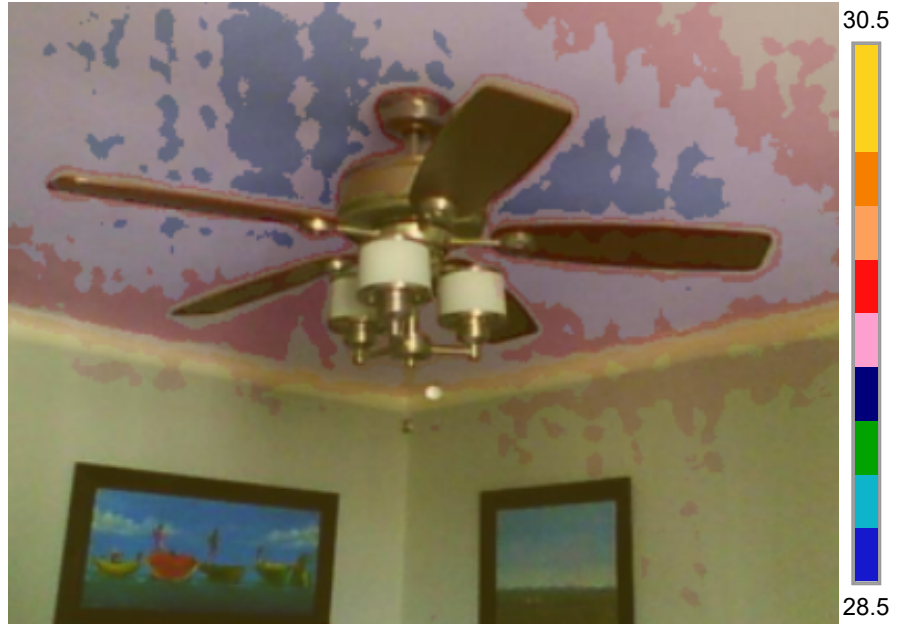
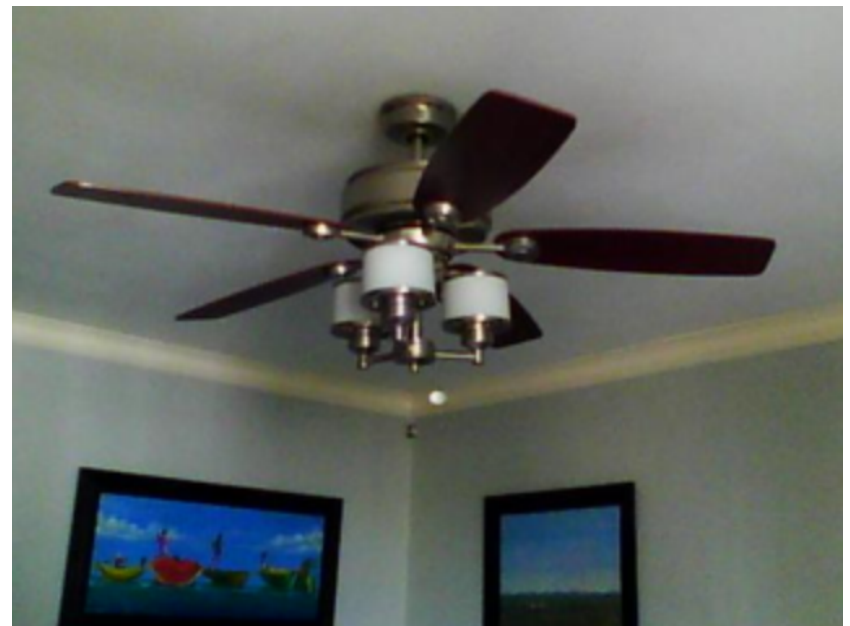
FLIR53673.jpg

Possible Origin of Damage Detected:
 Moisture displacement from the upper area to this position

We observed a moisture problem that moves from the ceiling and falls vertically down the walls. In order to identify the origin of this moisture, it is necessary to inspect this position and identify equipment and structures that may be causing this situation.

The humidity that we are observing will be reflected in the lower apartments as it moves by gravity vertically through the structural wall.

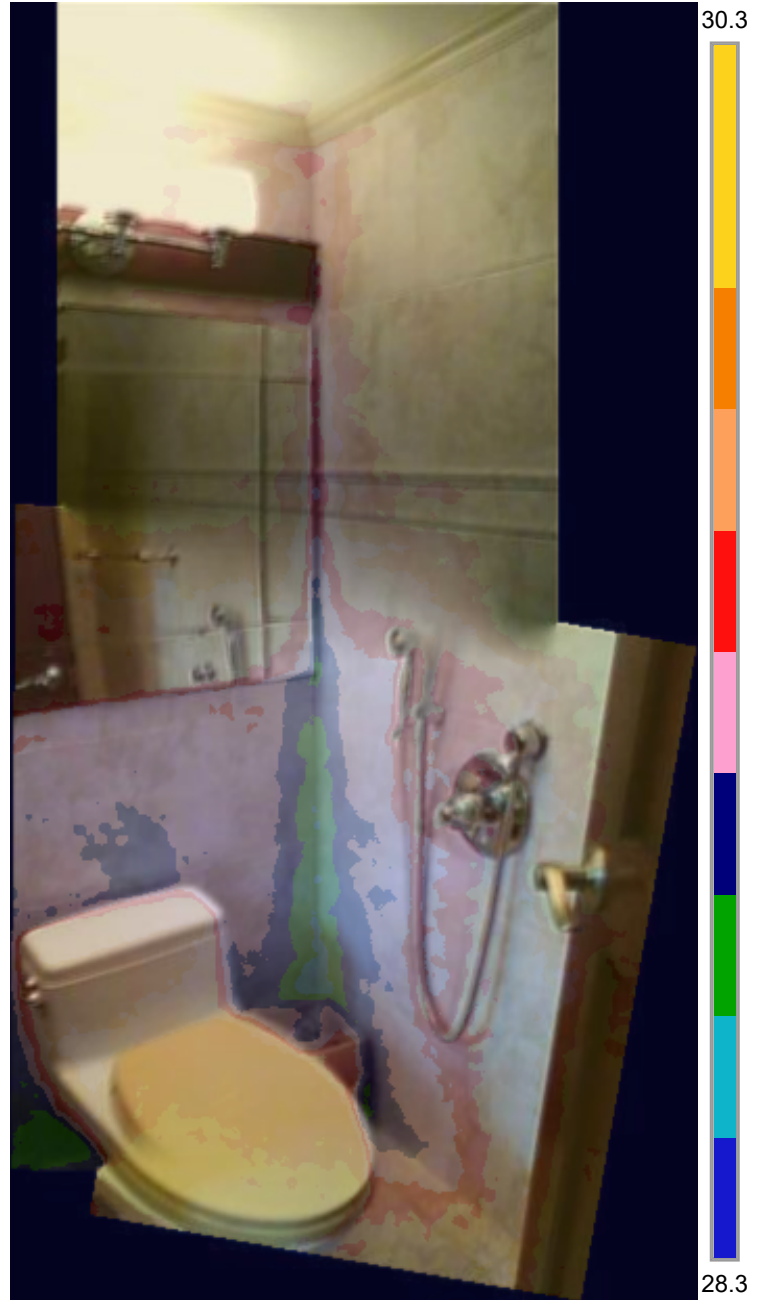
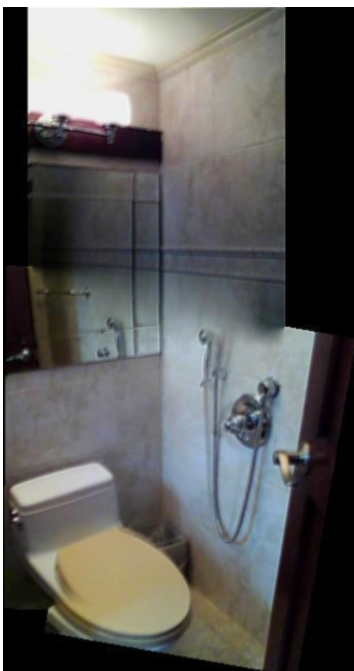
FLIR53675_panorama... FLIR E8 Wifi 639033909

Los daños que observaremos pueden incluir a los muebles de baño, equipos electrónicos y objetos adosados a las paredes perimetrales

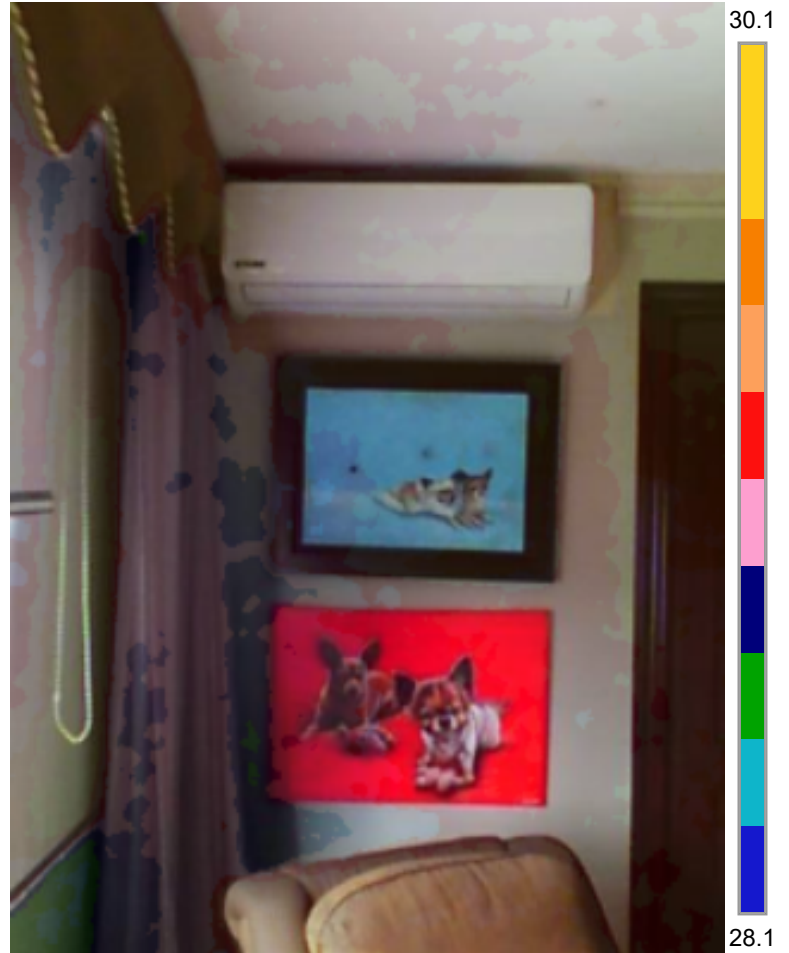
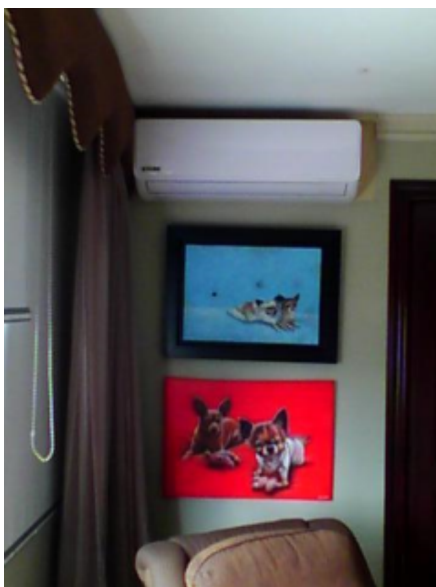
FLIR53682.jpg FLIR E8 Wifi 639033909

La unidad de aire acondicionado que observamos en la imagen no presenta un daño en este momento, pero debe ser revisada por un técnico calificado debido a la exposición de la humedad desde el techo lo cual acelerará cualquier daño que se pudiera producir a futuro

No descartamos un daño causado por una plataforma de aire acondicionado si la misma esta ubicada fuera de la ventana

Es importante realizar una inspección sobre esta posición para identificar el origen del daño e identificar si hay fuentes desconocidas que puedan causar el desplazamiento de humedad que produzcan la situación que se observa

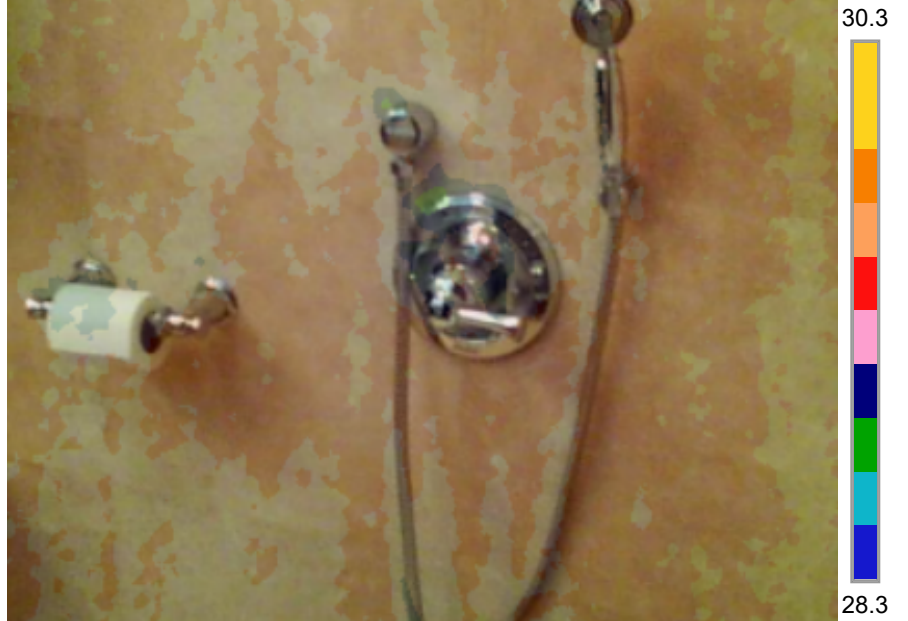
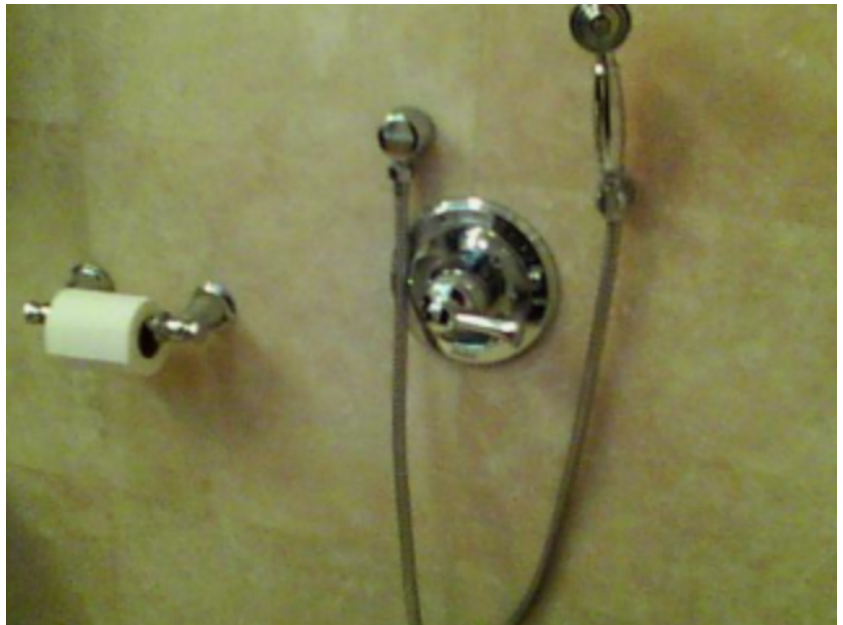
FLIR53684.jpg

Possible Origin of Damage Detected:
 We do not observe damage in this facility

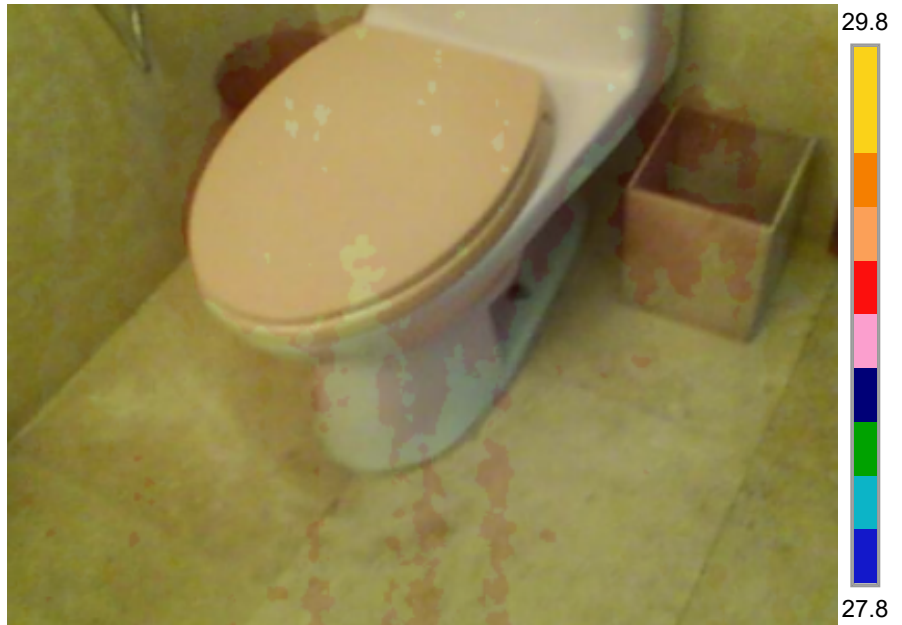
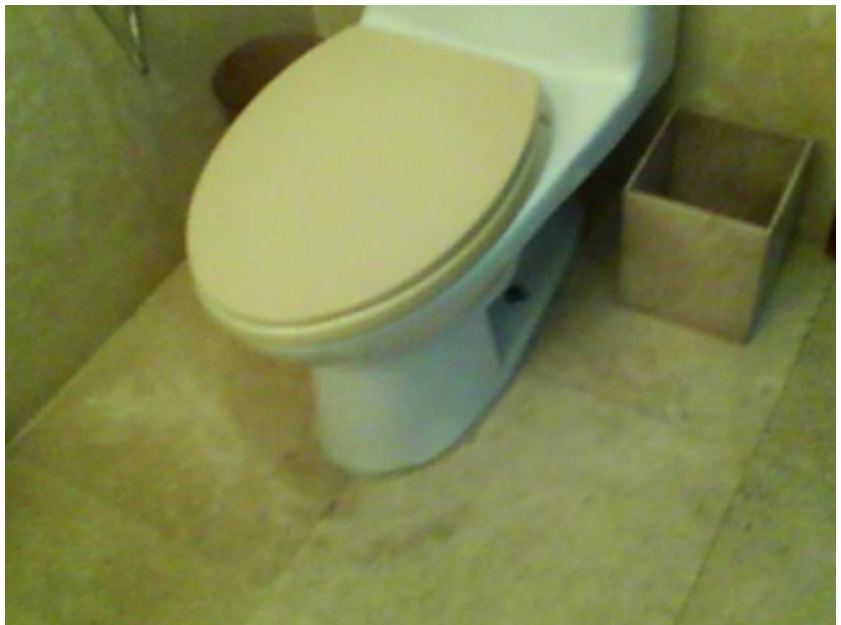
FLIR53685.jpg

Possible Origin of Damage Detected:
 We do not observe damage in this facility

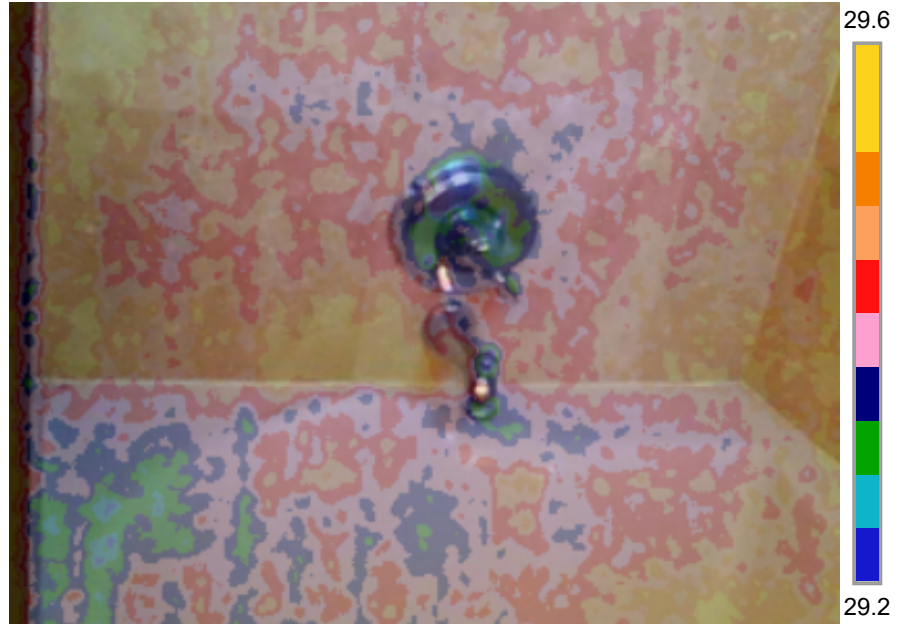
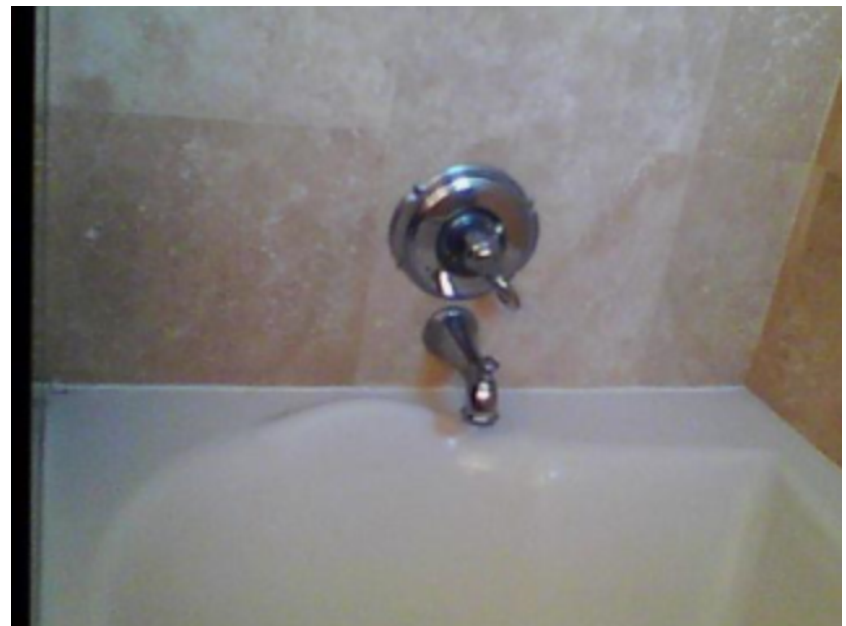
FLIR53687.jpg

Las consecuencias de este daño se observarán en las áreas inferiores al caer la humedad por gravedad a través de la pared estructural
